Illinois River and Tributaries: Streambank Erosion Inventory Report

Illinois River Watershed Partnership

January 2017

Natural State Streams LLC

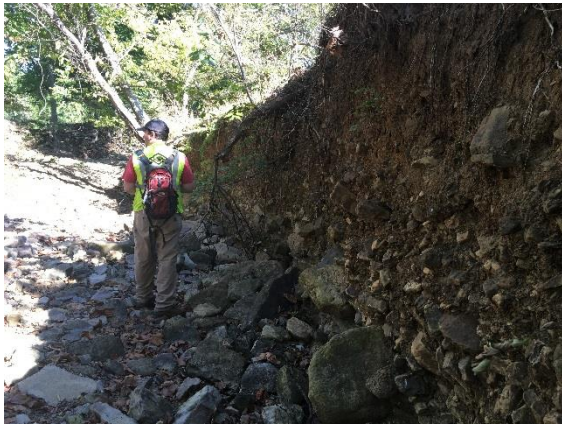
A total of 247 bank segments were inventoried on upper Muddy Fork with an average length of 265 feet each. Annual bank erosion estimates ranged from 0 to 3.36 feet/year with an average erosion rate of 0.36 feet/year for all streambanks catalogued. One streambank segment fell within the Extreme predicted erosion category (3-4 feet/year), two segments were categorized as Very High (2-3 feet/year) and twenty-two segments were predicted to be within the High category (1-2 feet/year). Areas with relatively high predicted erosion rates generally had low rooting depths and density as well as high bank height to bankfull height ratios (Figure 4).

Figure 4. High erosion on upper Muddy Fork.

proceed with extreme caution and with the consultation of a qualified restoration specialist.

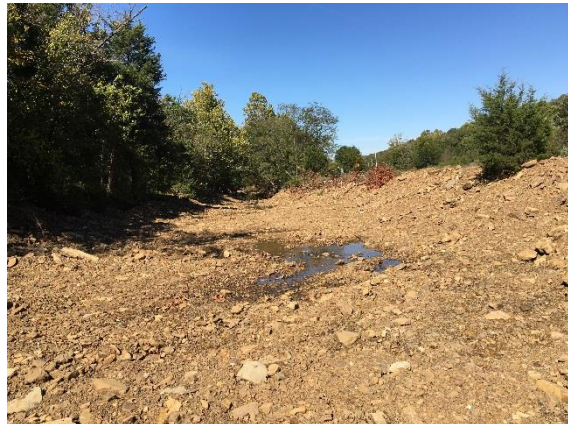
There are several areas where it is apparent that heavy equipment has recently been in the stream, likely an attempt by landowners to clear perceived blockages to flow or repair bank erosion (Figure 5). These 'fixes' may eventually exacerbate erosion onsite or downstream of the channel modifications by destabilizing the channel bed and banks. Any attempt at channel or streambank restoration should

Figure 5. Channel modifications on Muddy Fork.

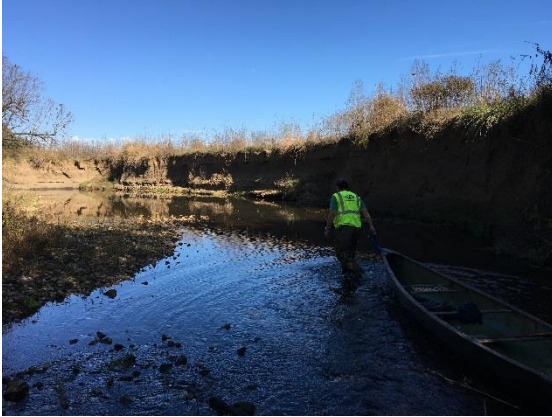
A total of 89 bank segments were inventoried on lower Muddy Fork with an average length of 238 feet each. Annual bank erosion estimates ranged from 0 to 2.98 feet/year with an average erosion rate of 0.77 feet/year for all streambanks catalogued. Thirteen streambank segments were categorized as Very High (2-3 feet/year) and thirteen segments were predicted to be within the High category (1-2 feet/year). Areas with relatively high predicted erosion rates generally had low riparian and rooting cover as well as high bank height to bankfull height ratios (Figure 6).

Figure 6. Very High erosion on Muddy Fork.

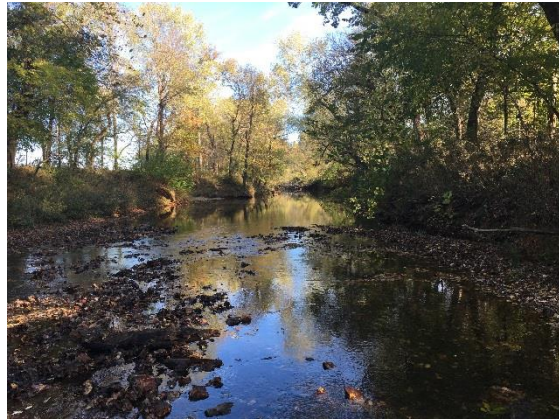
Figure 7. Stable section of lower Muddy Fork.

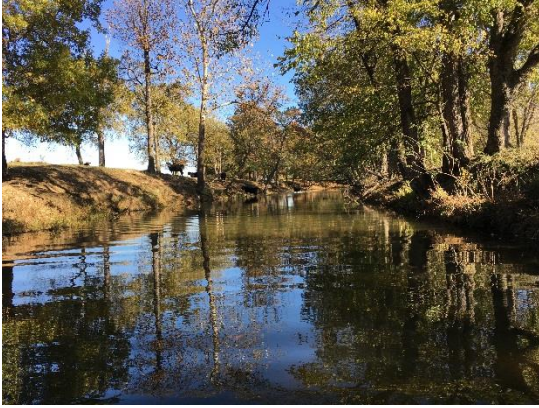
The lower reach of Moores Creek extends from the tailwaters of Lincoln Lake down to its confluence with Muddy Fork. This reach is approximately 4.77 miles in length, although a 1.22-mile section just downstream of N. Wedington Blacktop Rd. was not inventoried because we couldn't acquire landowner permission to access the creek. A total of 3.55 miles of Moores Creek was traversed by foot and canoe on November 15, 2016. This reach is characterized by perennial stream flow although water quality appeared to be less than ideal as evidenced by low water clarity, especially in areas where cattle were accessing the creek (Figure 11).

Figure 11. Cattle in lower Moores Creek.

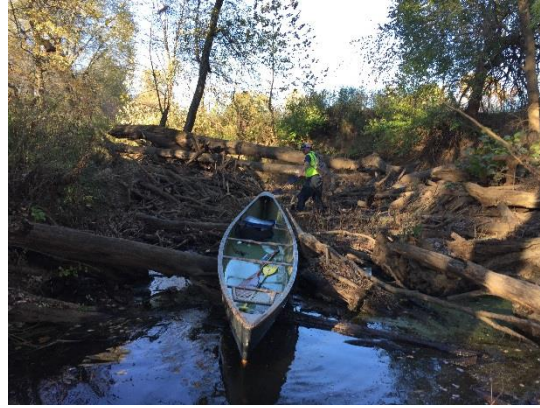
A total of 89 bank segments were inventoried on lower Moores Creek with an average length of 210 feet each. Annual bank erosion estimates ranged from 0 to 2.41 feet/year with an average erosion rate of 0.48 feet/year for all streambanks catalogued. One streambank segment fell within the Very High predicted erosion category (2-3 feet/year) and nineteen segments were predicted to have High erosion rates (1-2 feet/year). Areas with elevated erosion rates are characterized by extensive gravel point bar formation and a lack of adequate riparian corridor. The lowest 0.5 miles of Moores Creek, directly upstream of the confluence with Muddy Fork appears to be in a fairly unstable condition with bank erosion rates in the 0.5-2.0 feet/year range. Many large trees that have recently fallen into the creek have led to the formation of several large debris jams which may be exacerbating the bank erosion at this location (Figure12).

Figure 12. Debris jam on lower Moores Creek

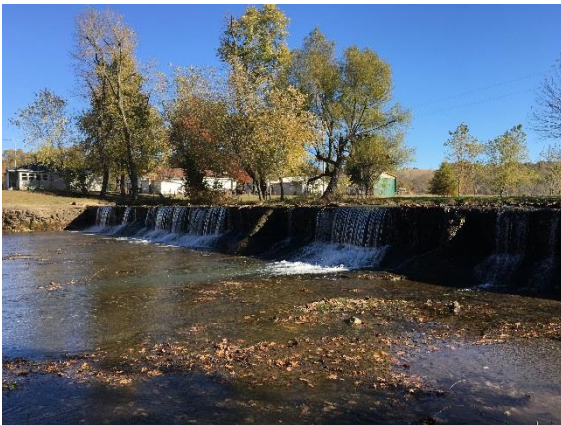
This study focused on the lowest 2.35 miles of Clear Creek down to its confluence with the Illinois River. This reach was floated by canoe on November 16, 2016. Overall stream health appeared to be good with excellent water clarity, relatively high base flow and seemingly abundant fish populations. There is a low-head dam approximately 8 foot in height that impounds roughly 0.6 miles of Clear Creek within this reach as well as an old concrete low water crossing (Figures 14&15). Both of these structures may be acting as un-natural barriers to fish passage during normal flows.

Figure 14. Dam on Clear Creek

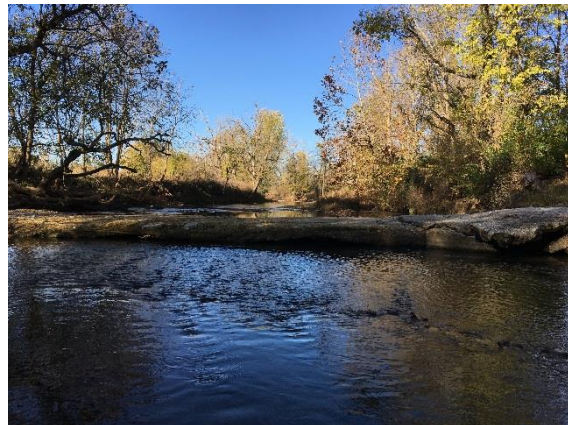
Figure 15. Low water crossing on Clear Creek

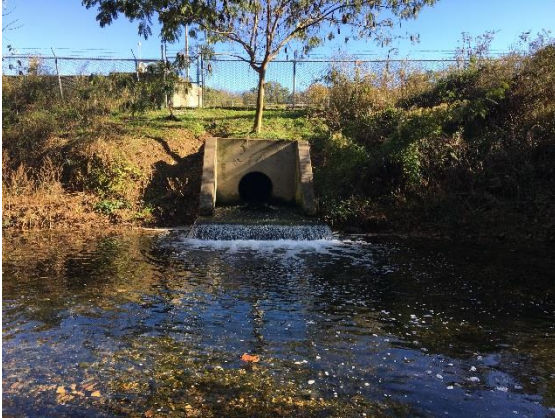
Figure 17. Wastewater effluent in Sager Creek.

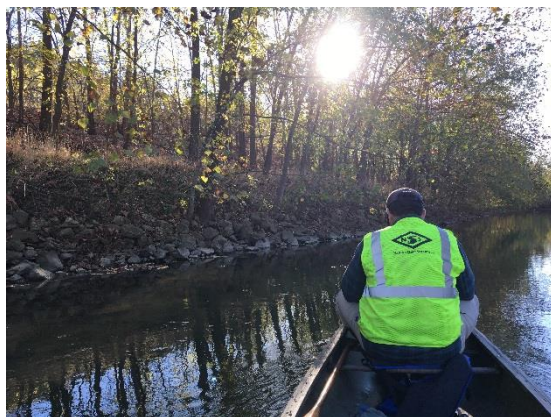
Figure 22. AHTD Riprap near Hwy 412

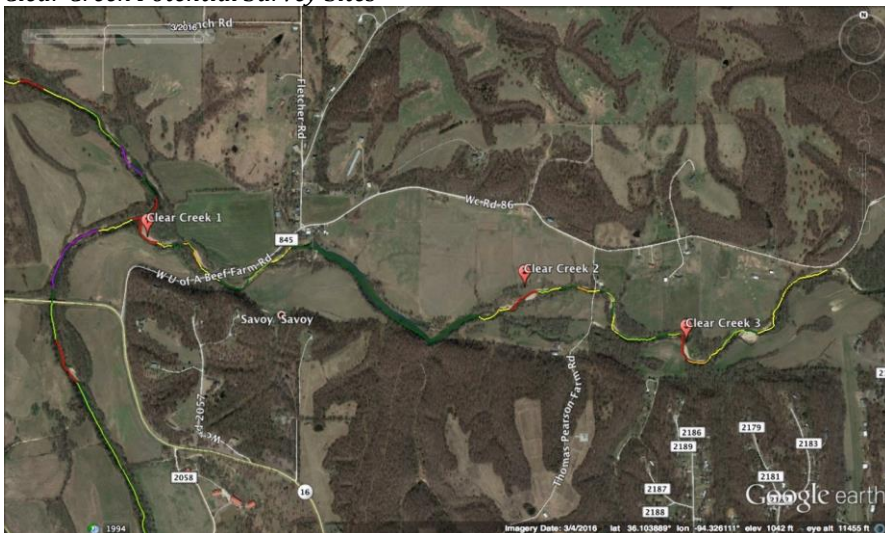
Clear Creek Potential Survey Sites

Three areas on Clear Creek had Very High predicted rates of erosion. (1) The streambank at the mouth of the river, (2) the streambank approximately 0.63 miles upstream of the Savoy Lake Dam, and (3) the streambank approximately 1.19 miles upstream of the Savoy Lake Dam would be ideal areas to establish permanent survey sites.

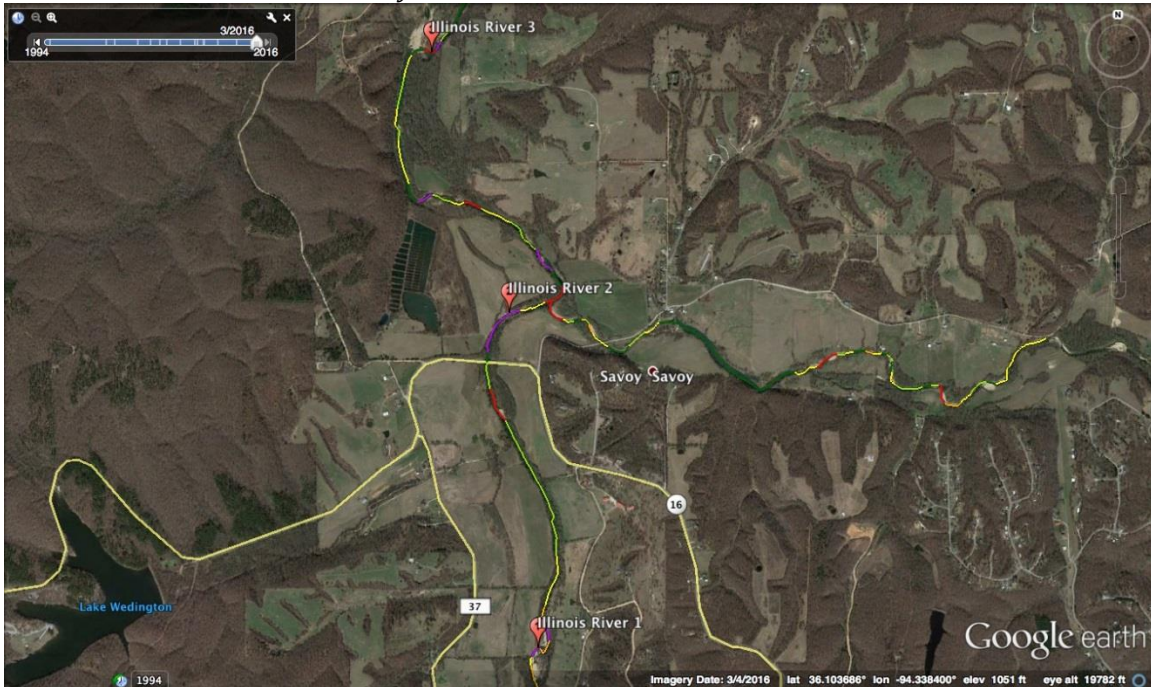
Middle Illinois River Potential Survey Sites

Several areas were identified as Very High or Extreme predicted rates of erosion on the Illinois River. The four areas with the highest rates are described below. (1) The streambank approximately 1.1 miles upstream of the Hwy 16 bridge, (2) the area immediately downstream of the Hwy 16, (3) the streambank approximately 1.7 miles downstream of the Hwy 16 bridge, (4) and the streambank approximately 0.4 miles upstream from the Hwy 59 bridge would be idea areas to establish permanent survey sites.

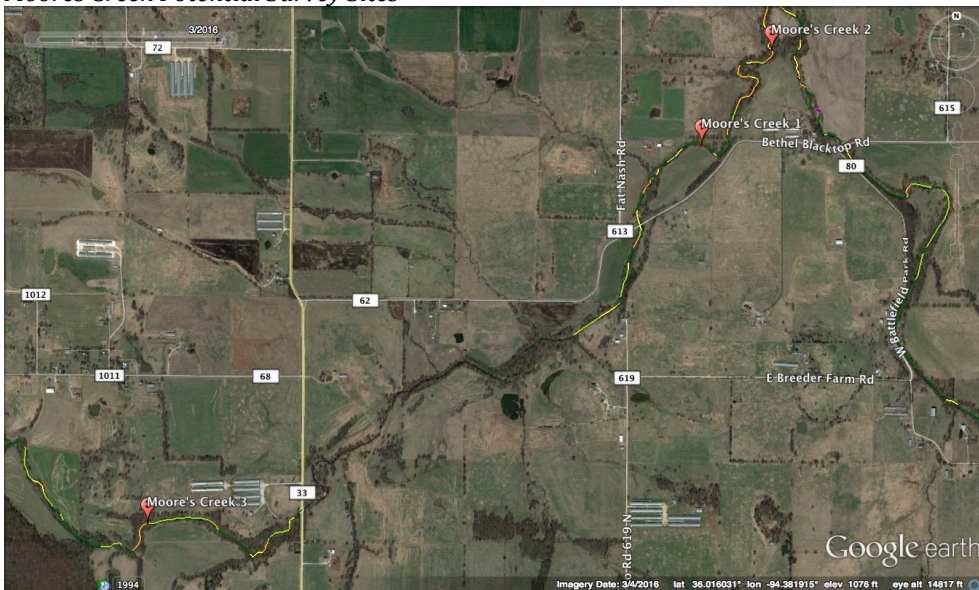
Moore's Creek Potential Survey Sites

Moore's Creek had several High and Very High predicted areas of erosion that were identified during the stream inventory. (1) The streambank approximately 0.35 miles downstream of Bethel Blacktop Rd/Hwy 62, (2) the area just upstream from the confluence with Muddy Fork, (3) and the streambank approximately 1.32 miles downstream from the Lincoln Lake Dam would be ideal areas to establish permanent survey sites.

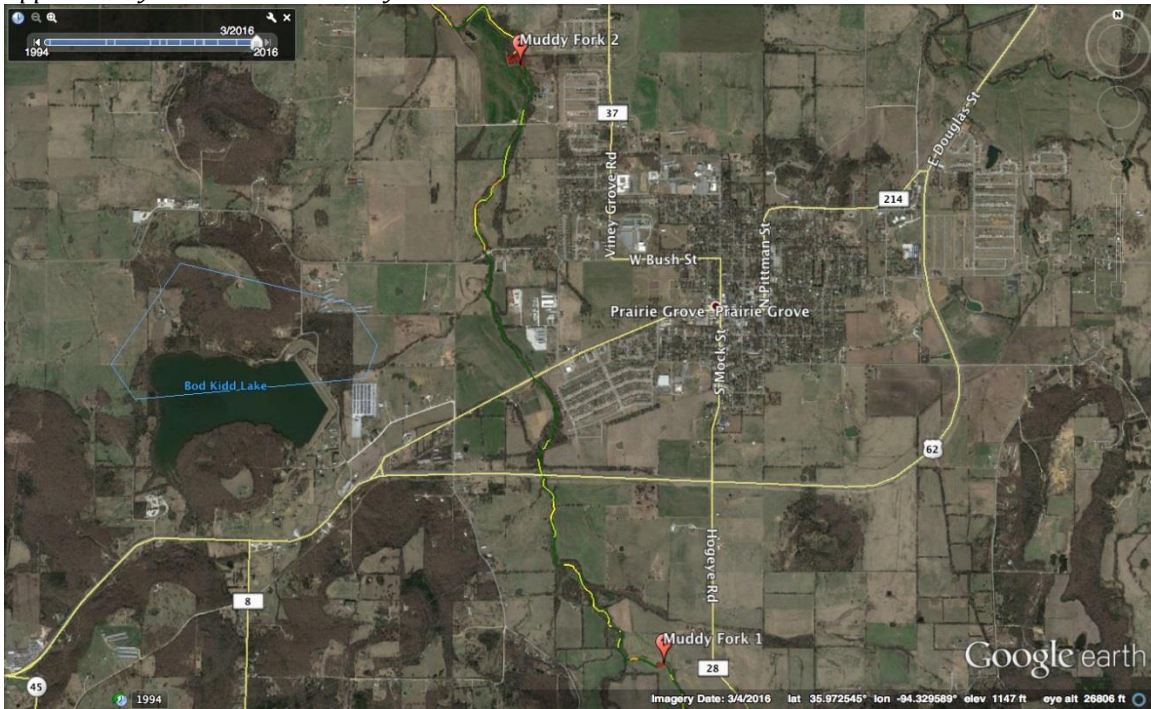
Upper Muddy Fork Potential Survey Sites

Multiple sites and areas were identified as Very High and Extreme potential erosion rates on Muddy Fork. They are described below. (1) The streambank approximately 1.25 miles upstream from Hwy 62, (2) the streambank approximately 2.27 miles downstream from Hwy 62, (3) the streambank approximately 0.14 miles downstream from Bethel Blacktop/Hwy 62, (4) the streambank approximately 1.01 miles downstream from Bethel Blacktop/Hwy 62, (5) the streambank approximately 1.54 miles downstream from Bethel Blacktop/Hwy 62, (6) the streambank approximately 0.71 miles upstream from Hwy 37, and (7) the area just upstream from the confluence with the Illinois River.

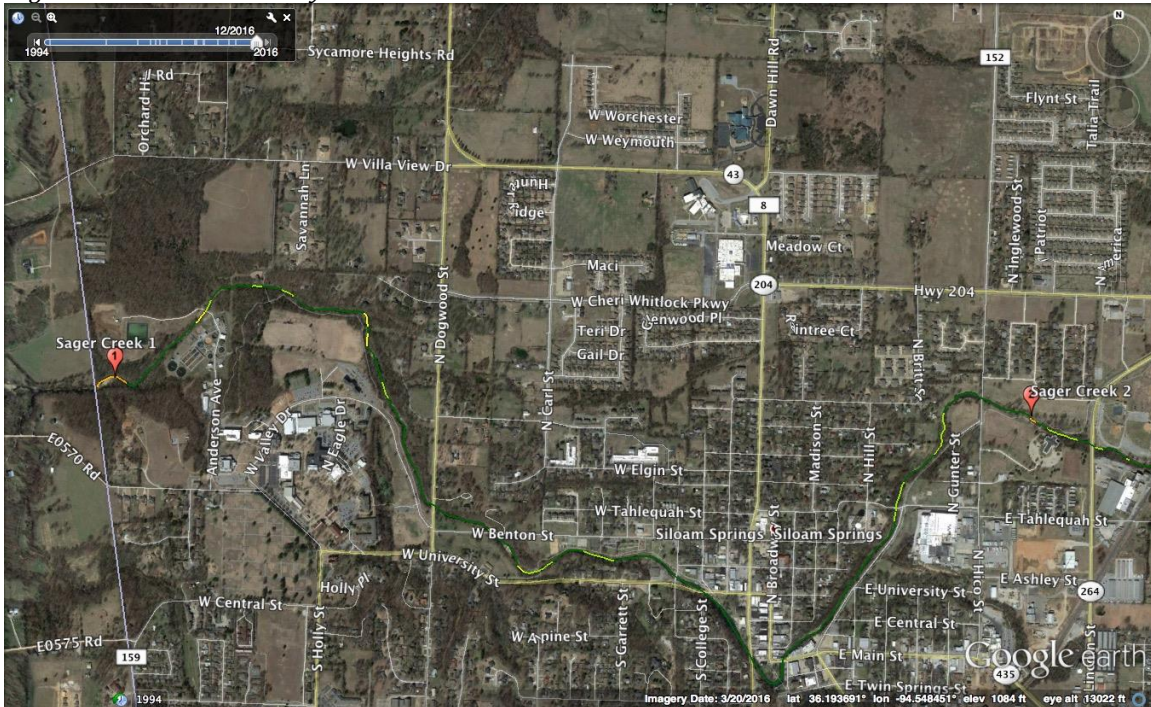
Sager Creek Potential Survey Sites

Sager Creek had the fewest areas with high predicted rates of erosion. (1) The steambank just upstream from the state line and (2) the steambank approximately 0.15 miles downstream from N. Lincoln St. were identified as potential permanent survey sites.
