# SUBWATERSHED ASSESSMENT FOR THE UPPER ILLINOIS RIVER WATERSHED

### Introduction

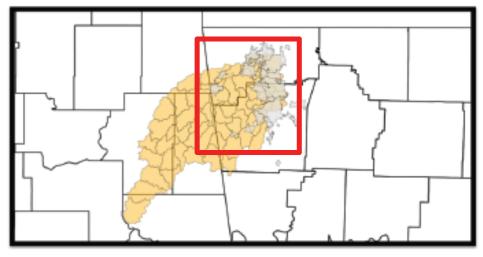
Figure 1. The Illinois River Watershed is an interstate watershed with a delineated boundary in Arkansas and Oklahoma. Area of interest (i.e., Upper Illinois River Watershed) is outlined in red.

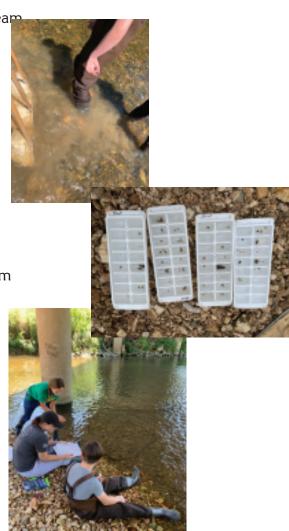
Figure 1. Photos depicting macroinvertebrate and stream characteristic collection of Clear Creek 2019.
