Illinois River and Tributaries: Streambank Erosion Inventory Report

Illinois River Watershed Partnership

January 2017

Natural State Streams LLC

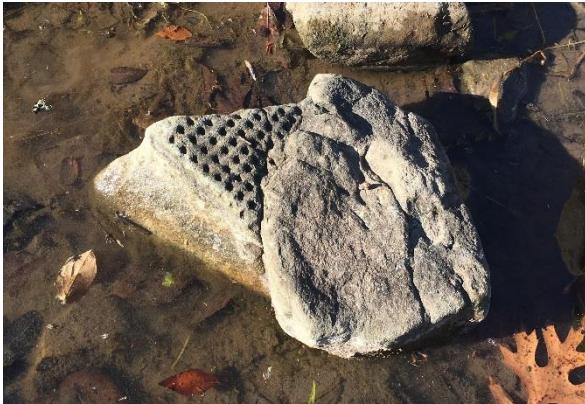
A large wooded area just upstream of Lincoln Lake and surrounding both sides of Moores Creek potentially has high conservation value. It is currently in private ownership. The area is steep and rugged with bluffs, overhangs and interesting geology. The creek at this location would serve as a good reference reach for future restoration work as well because of its relative pristine condition (Figures 9&10).

Figure 9. *Lepidodendron* fossil in Moores Creek.

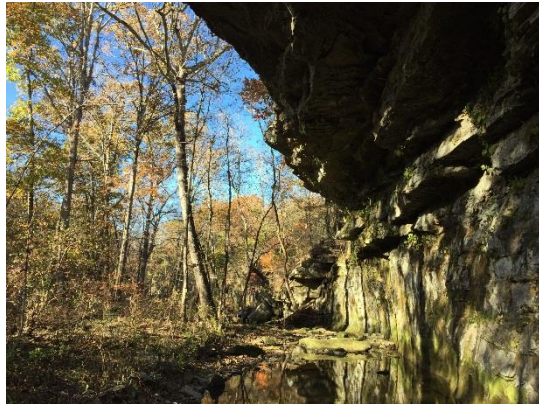
Figure 10. Large bluff on upper Moores Creek.

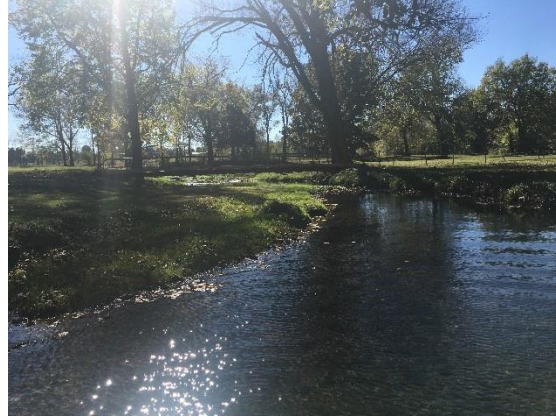
The drainage area of Sager Creek is 13.2 square miles at the Oklahoma-Arkansas state line (Figure 16). Primarily grassy low-gradient pastures and urban areas encompassing most of Siloam Springs characterize the watershed. Sager Creek also flows through Siloam Springs Golf Course, where there are several springs that provide perennial streamflow to downstream reaches (Figure 18). Upstream of the golf course, flows are ephemeral or intermittent.

Figure 18. Siloam Springs Golf Course.

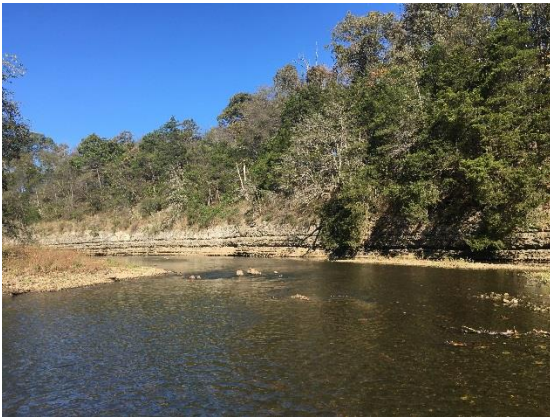
Those areas that are experiencing high to extreme levels of streambank erosion are characterized by extensive gravel point and transverse bar formation and a lack of adequate riparian corridor. Areas with highly vegetated and/or bedrock banks were particularly stable (Figure 21), while the Illinois River near the confluence with Clear Creek is one of the problem areas on this reach, potentially exacerbated by the influence of the dam on Clear Creek. This reach likely has elevated bedload sediment, consisting mainly of gravel and finer materials from local bank erosion and upstream sources. The deposition of these materials in the active channel and migration of gravel bars can often lead to areas with high near bank stress and, consequently, bank erosion.

Figure 21. Bedrock Outcrop on Middle Illinois

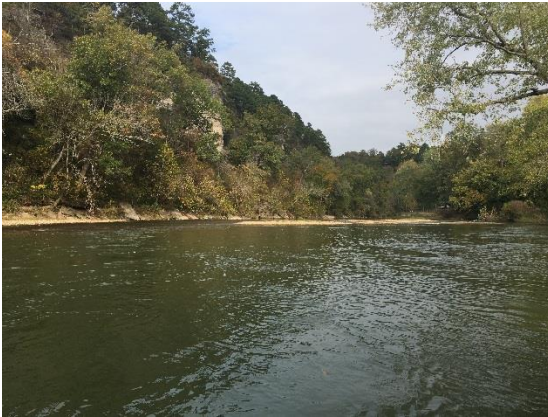
A total of 47 bank segments were inventoried on the Lower Illinois River with an average length of 383 feet each. Annual bank erosion estimates ranged from 0 to 4.0 feet/year with an average erosion rate of 0.72 feet/year for all streambanks catalogued. One streambank segments was predicted to have Extreme annual erosion rates (3+ feet/year) while four segments fell within the Very High predicted erosion category (2-3 feet/year), and four segments were categorized within the High predicted erosion category (1-2 feet/year). Areas inventoried with low predicted erosion rates were highly vegetated and/or had a high bedrock component in the banks (Figures 23&24).

Figure 23. Bedrock outcrop on Illinois River

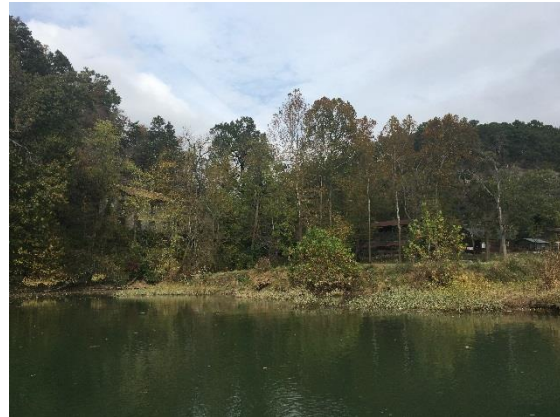
Figure 24. Typical deep pool on Illinois River
